KATY ALLEN LAKE DAM
VERNON COUNTY, MISSOURI
MO 20207

PHASE 1 INSPECTION REPORT NATIONAL DAM SAFETY PROGRAM

KATY ALLEN DAM
VERNON COUNTY, MISSOURI
MISSOURI INVENTORY NO. 20207

Name of Dam:	Katy Allen Dam
State Located:	Missouri
County Located:	Vernon County
Stream:	Willow Branch
Date of Inspection:	21 June 1979

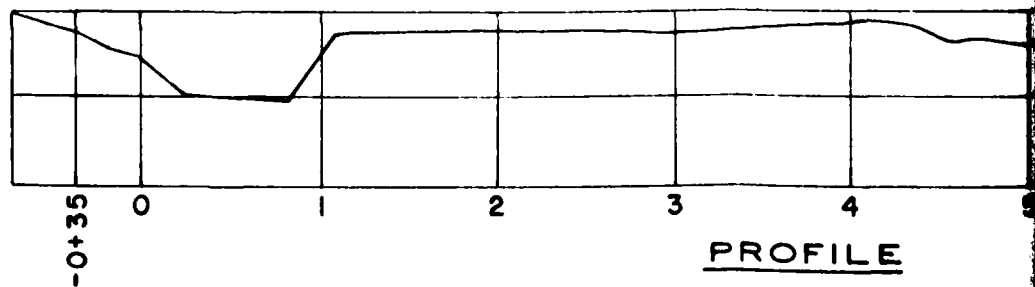
NORTH SPILLWAY PROFILE

The only appurtenant structures associated with this dam are the two concrete spillways. The control sections are in fair condition. The concrete below the crest is broken and the north spillway is apparently undermined as water was running under the concrete.

- (6) The concrete control sections and concrete spillway outlets should be inspected by a professional engineer to determine extent of undermining and if necessary rehabilitation of these structures.
- (7) The large tree in the approach to the south spillway and the plants in the approach to the north spillway should be removed.
- (8) Erosion protection should be provided on the south bank of the south spillway where the channel is eroding into the adjacent roadbed.
- (9) A detailed inspection of the dam should be made periodically by an engineer experienced in the design and construction of dams.

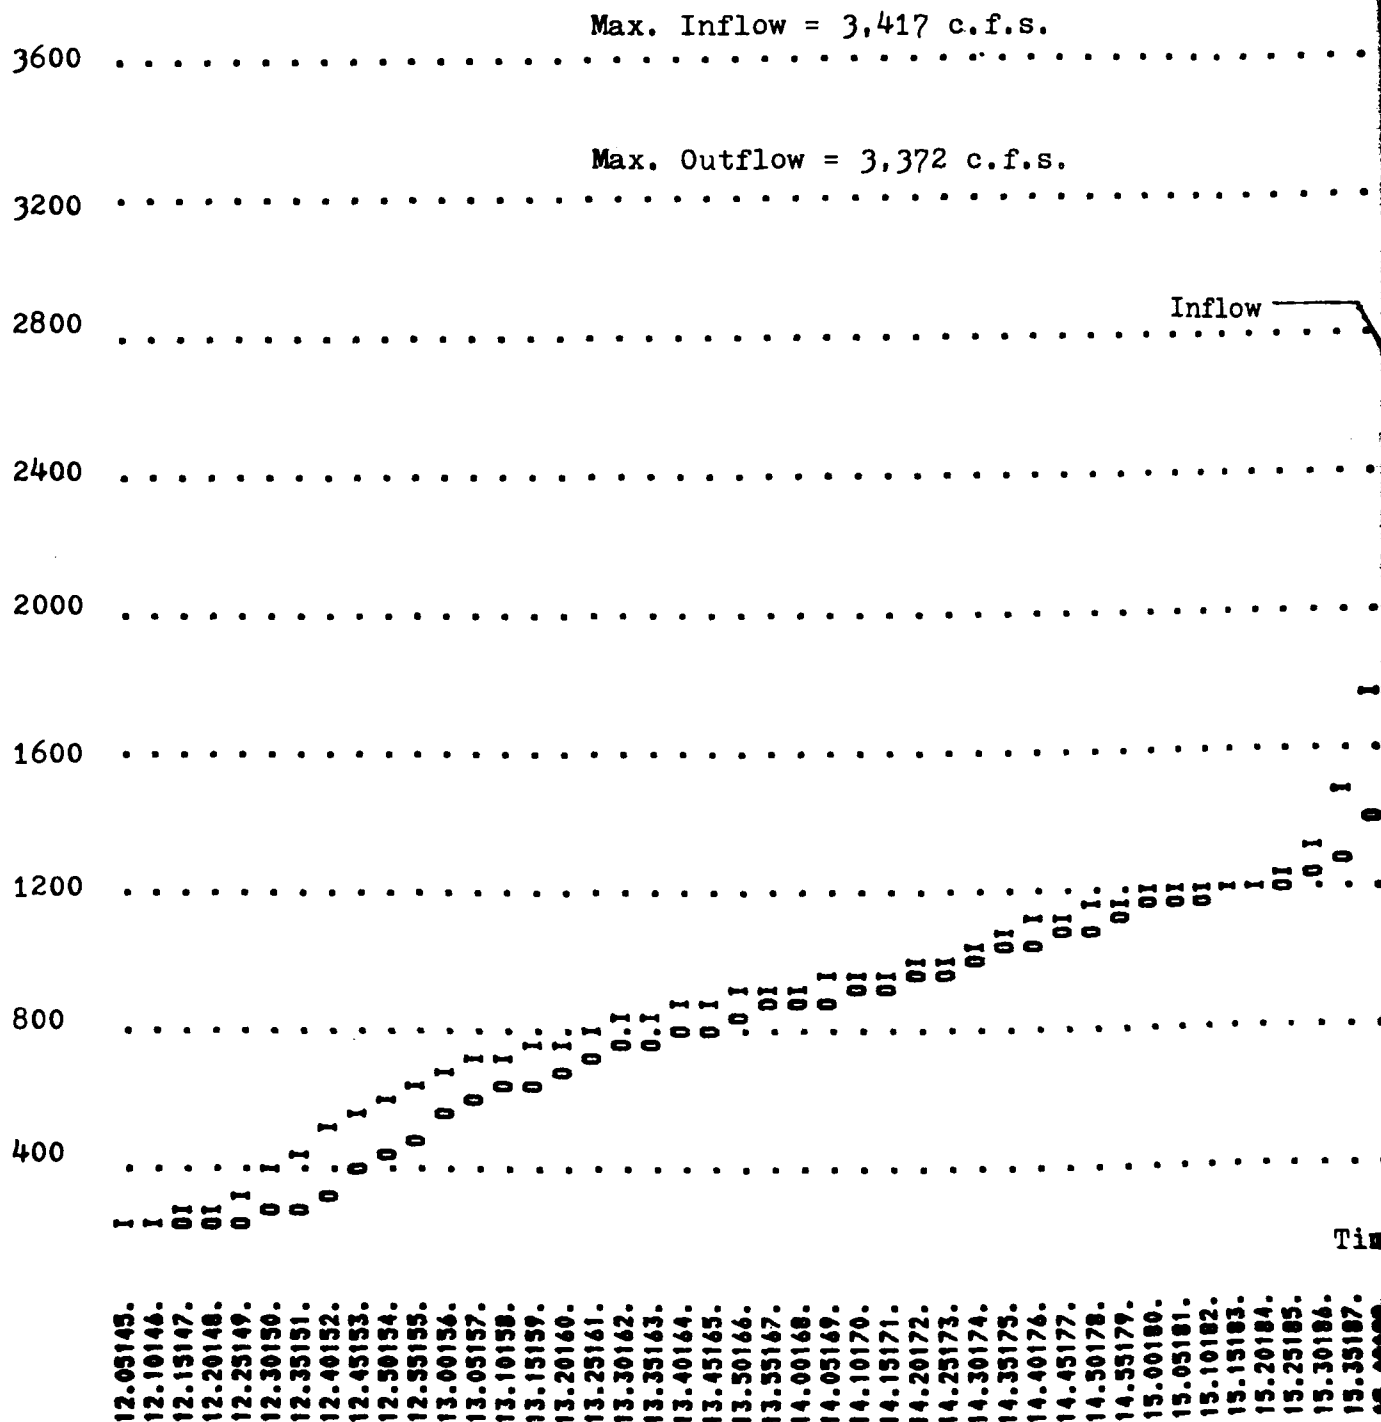
INFLOW - OUTFLOW
HYDROGRAPH
FOR 50% P. M. F.

Our inspection and evaluation indicates that the combined spillways do not meet the criteria set forth in the guidelines for a dam having the above size and hazard potential. The combined spillways will pass 41 percent of the Probable Maximum Flood without overtopping. The Probable Maximum Flood is defined as the flood discharge that may be expected from the most severe combination of critical meteorologic and hydrologic conditions that are reasonably possible in the region. The guidelines require that a dam of small size with a high downstream hazard potential pass 50
